East Banqueting House, Chipping Campden 1990

Report on a watching brief, March 1990

Jon Hoyle
Archaeology service
Gloucestershire county council
May 2018

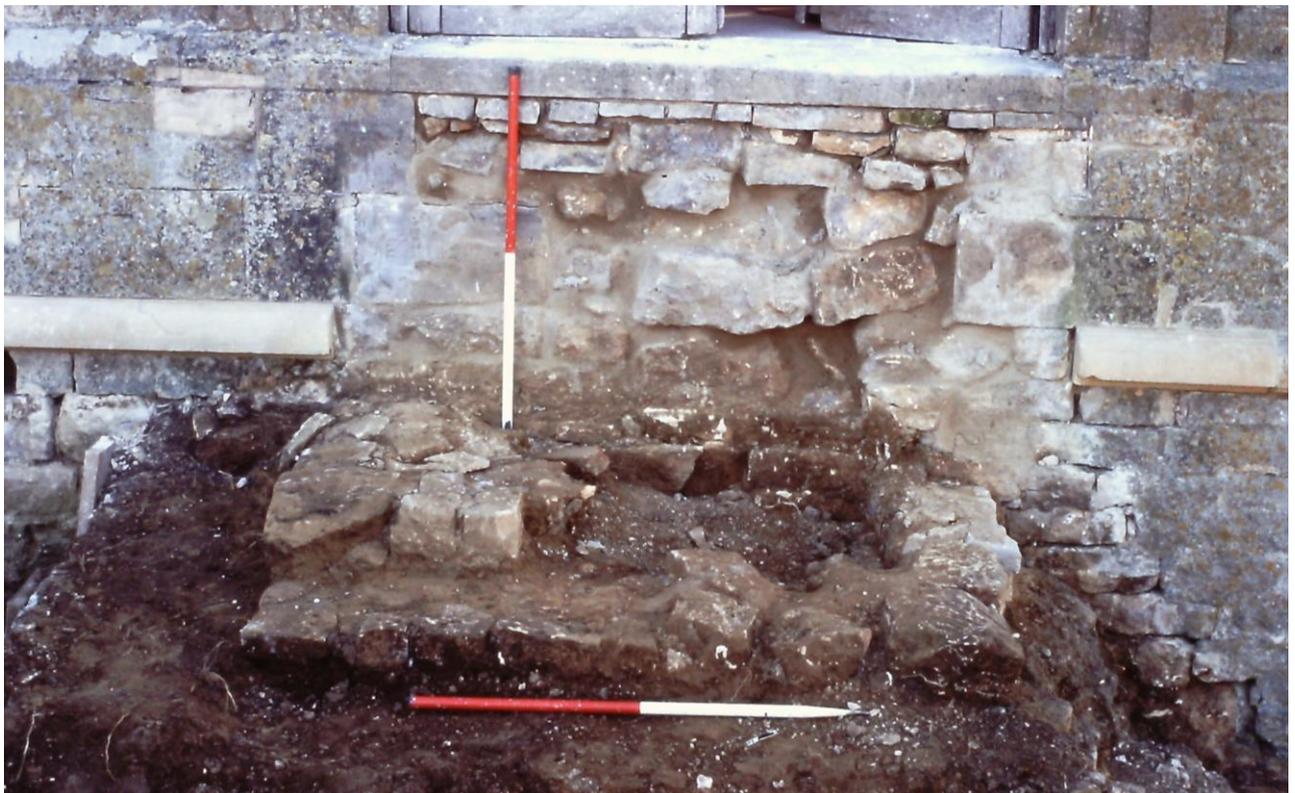
The flight of stone steps leading to the entrance on the western side of the building were removed. The steps themselves, which were made up of four courses of squared limestone blocks, attained a height of 0.93m and projected c. 1m out from the western face of the building. Below this was a foundation of large limestone rubble in a matrix of brownish yellow sand (7) which was essentially a revetting material for an infill of yellow brown silt clay with some limestone fragments (9)/(12). This basework projected out a further 1.8m from the Banqueting House's western wall. It was c. 1.10m deep and abutted and appeared loosely bonded with the Banqueting House's western wall (8). The base work (7) overlay material which had been dumped to create the terrace which abutted the Banqueting House's western wall. It was, however, also abutted by the upper layers of these dumps suggesting that the construction of the steps was undertaken contemporaneously with the finalisation of the laying of terrace embankment.

Figure 2: Basework for steps leading to the western entrance under excavation. Scale 1m (50cm divisions)

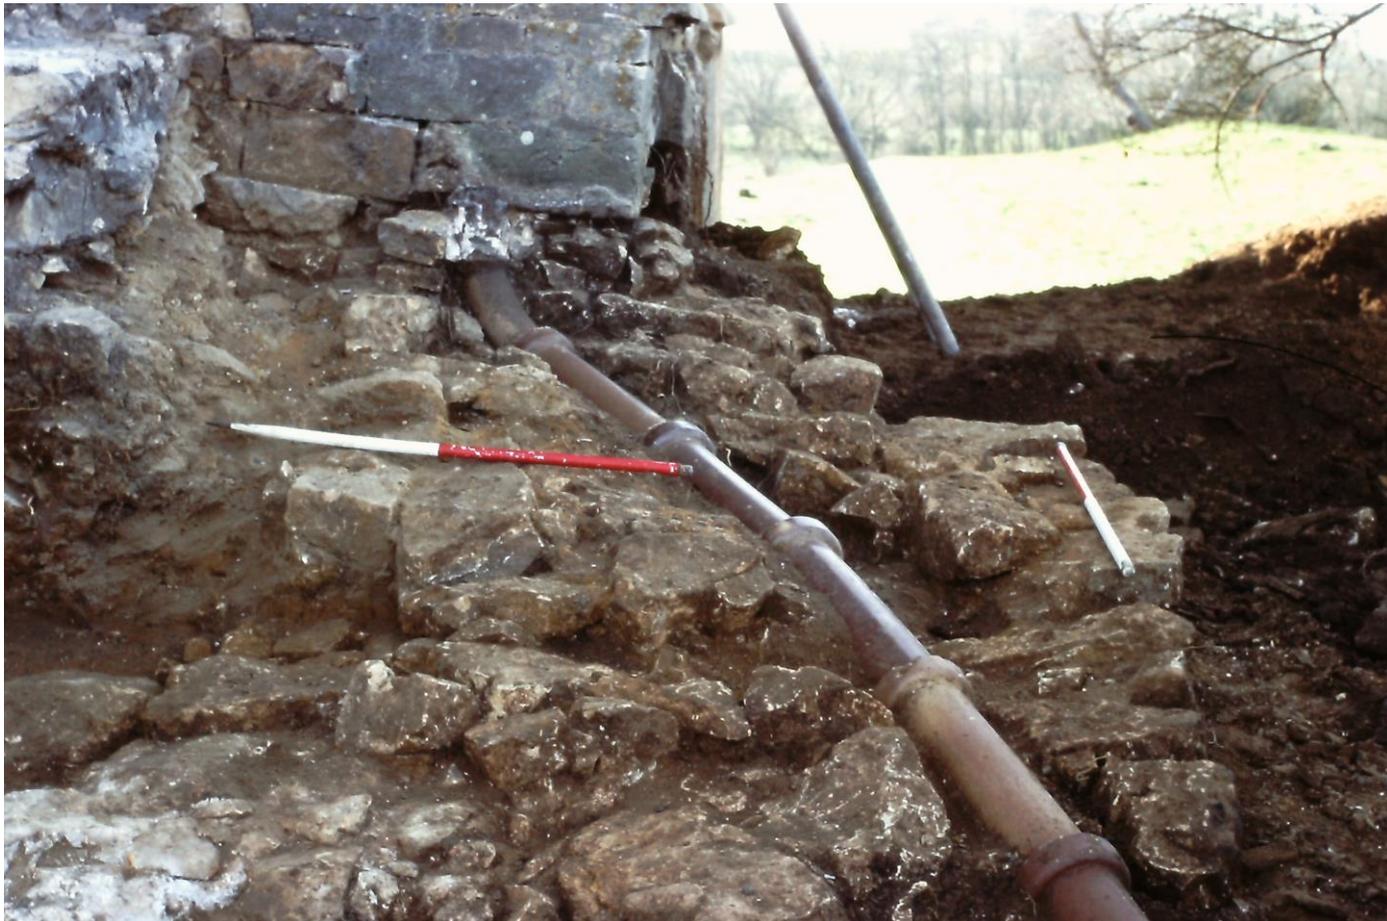
Figure 3: Stone structure (22)/(25) cut by later drain [29]. Scale 1m (50cm divisions)

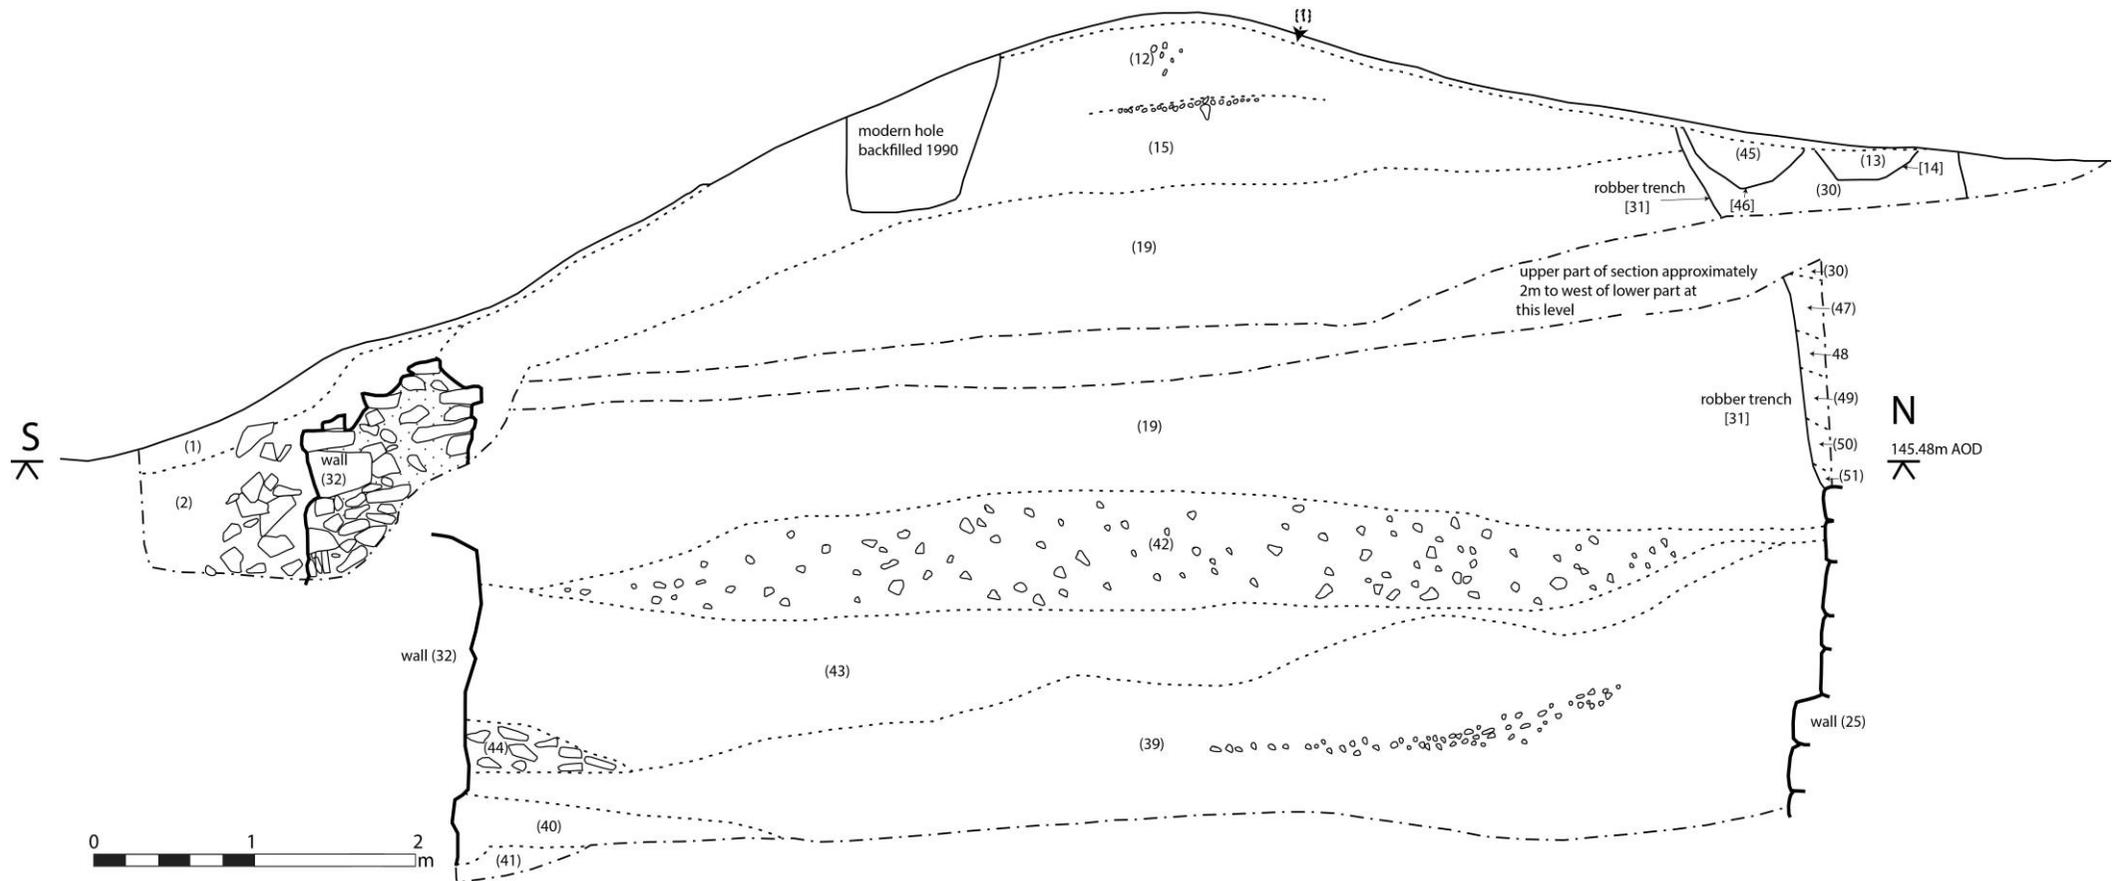
The terrace embankment dumps abutted the western and northern walls of the East Banqueting House, (8), (26) and (28), and these walls were noticeably less-well faced where these were hidden by the terrace embankment dumps. Immediately to the west of the Banqueting House this material was over 4m thick and may have been dumped directly on the surface of the undisturbed subsoil suggesting that the area had been stripped of turf before works began. Some doubt remains over this interpretation, however, given the equivocal status of context (56) currently interpreted as a possible buried soil in the area of the northern porch (see above).

Figure 4: Section through terrace embankment dumps

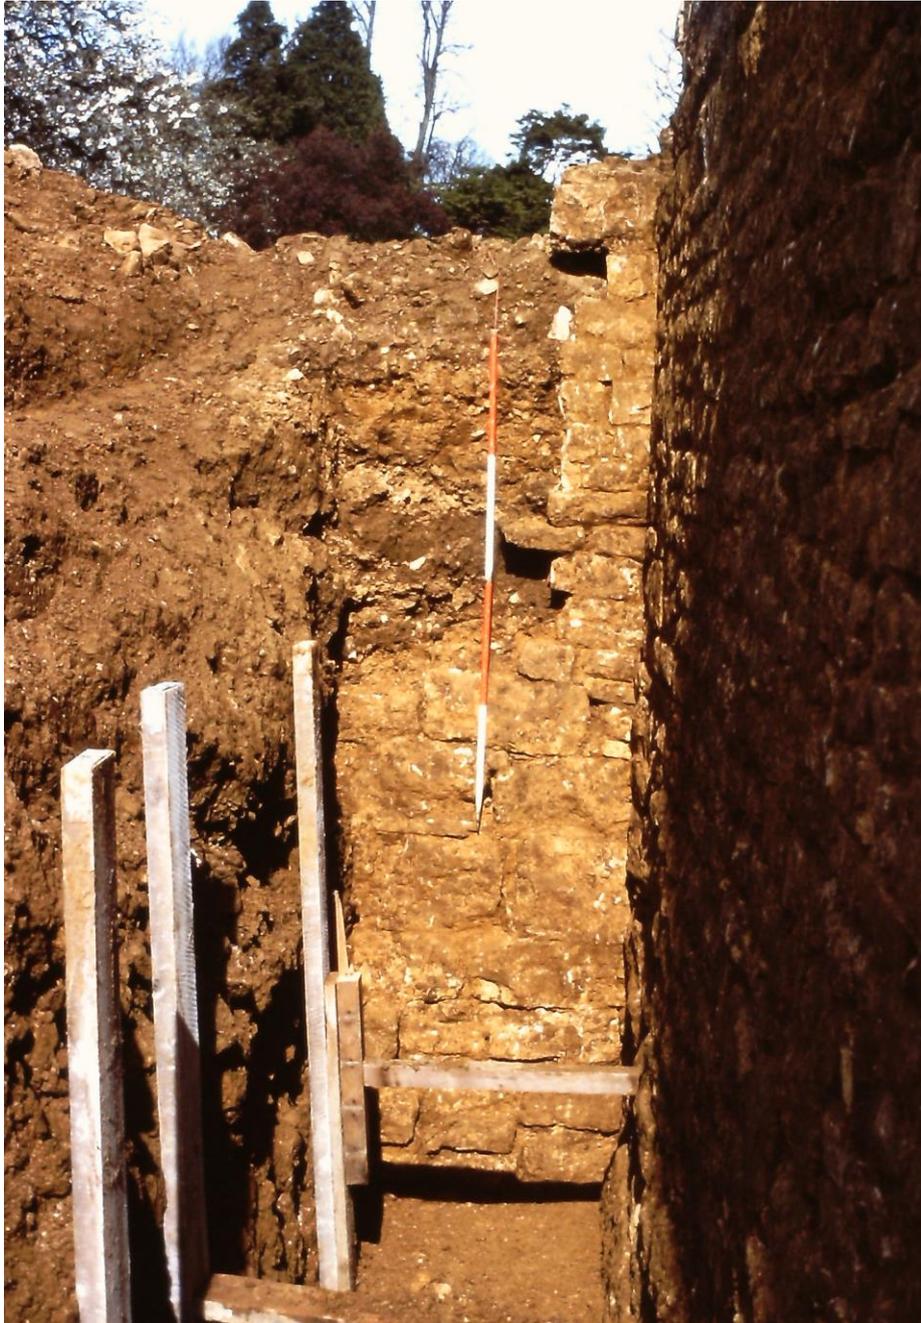
Figure 5: Northern terrace embankment wall. Note upper part robbed. View north, scale 2m (50cm divisions)

Wall (25) which sprang from the northwestern corner of the Banqueting House (24) had been robbed leaving only a nub of the wall c. 45cm long (see Figure 5). To the west of this wall (25) had been robbed within a narrow robber trench [31] to a depth of c. 2m, removing the smaller stones of its upper structure but bottoming out when the larger foundation stones were encountered. This trench was visible within the whole of the recorded area but it is not clear how far this continued to the west of this. Robber trench [31] was filled with brownish-yellow to yellowish brown sandy silt clay with a variable stone content (30)/(47)/(48)/(49)/(50)/(51) which produced animal bone, a fragment of 18th/19th century bottle glass/a stone paving

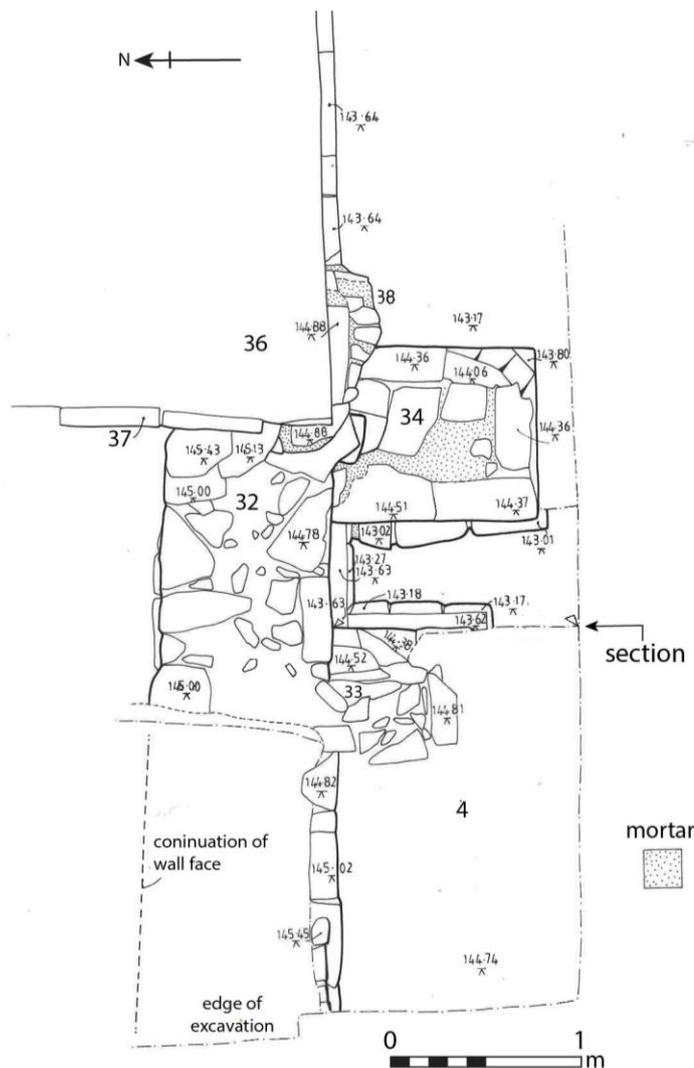
Approximately 1m to the west of the southwestern corner of the Banqueting House a buttress (33) was attached to the southern face of the terrace revetment. Where originally exposed this consisted only of an irregular mass of vertically pitched stonework, but further excavation exposed its eastern face (along with a small section of the southern face of terrace revetment (24) and the western face of later buttress (34)) to foundation level.

Buttress (33) protruded from the face of terrace wall (32) by c. 76cm and, in places, appeared to abut the face of the terrace wall. Some sections were, however, bonded with the terrace wall and the two were of similar build and finish including the course of chamfered stone on the face of terrace wall (32) which continued onto the face of the buttress. Buttress (33) can, therefore, be interpreted as an original feature of the terrace wall.

Figure 6: Plan of southern terrace wall (32). Note original buttress (33) and additional buttress (34)

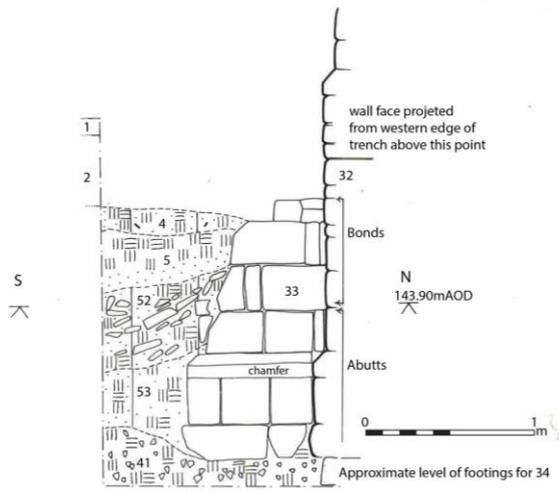
Figure 7: Elevation of original butters (33) attached to southern terrace wall (32)

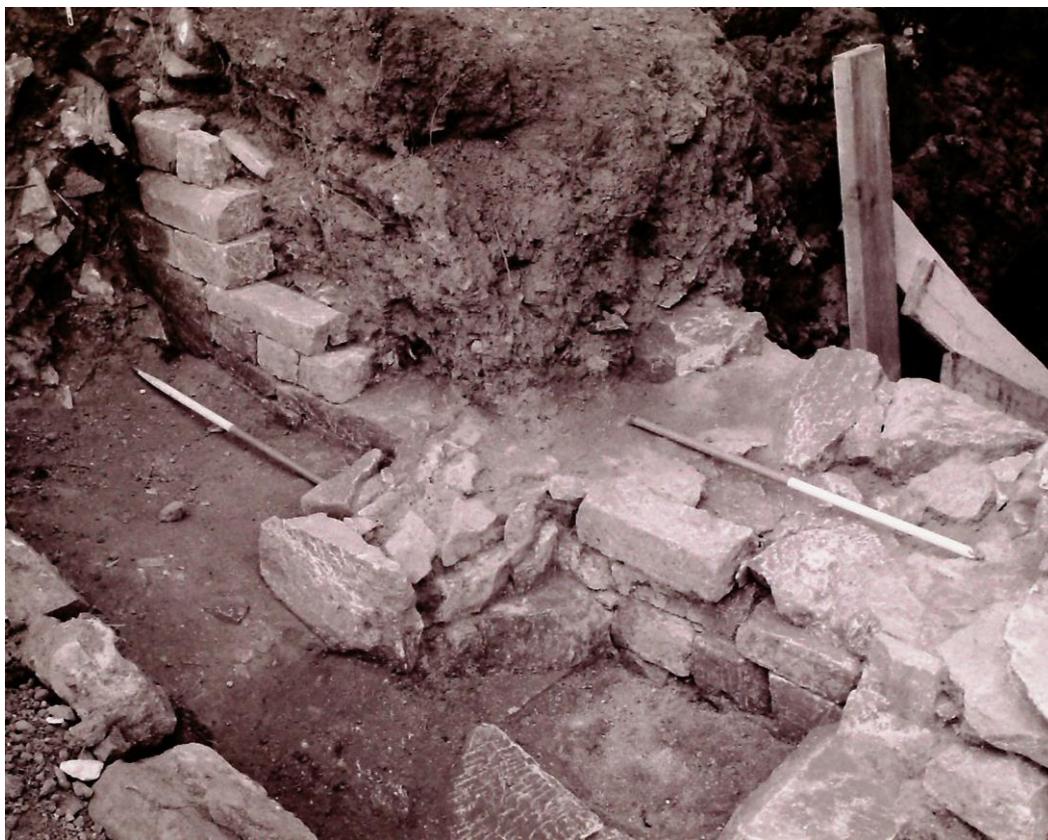
Figure 8: Exposed face of southern terrace wall. View northwest, scale 2m (50cm divisions)

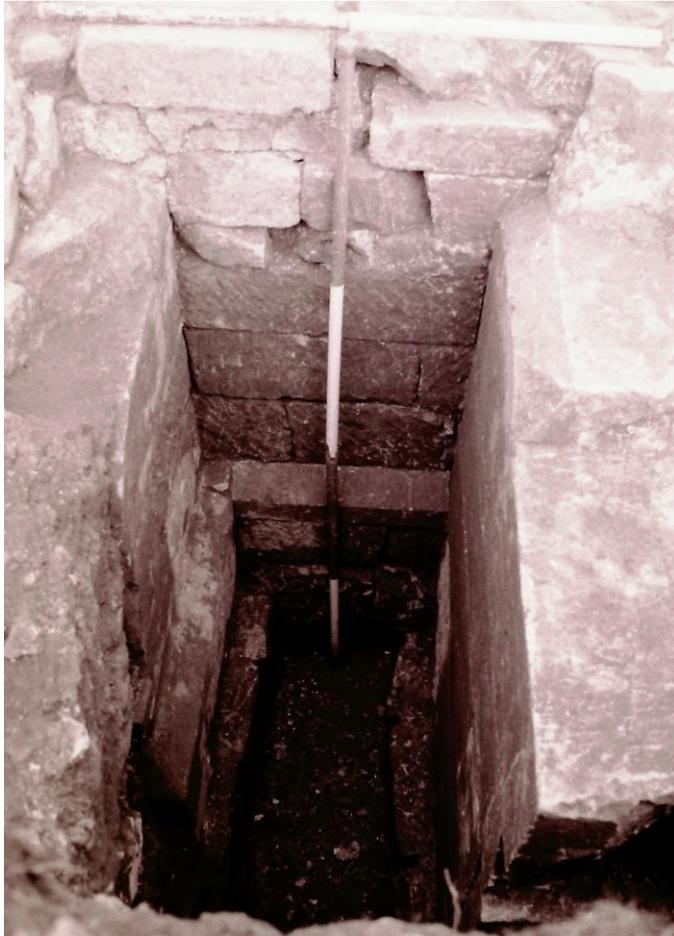
Figure 9: Face of southern terrace wall between buttresses. View north scale 2m (50cm divisions)

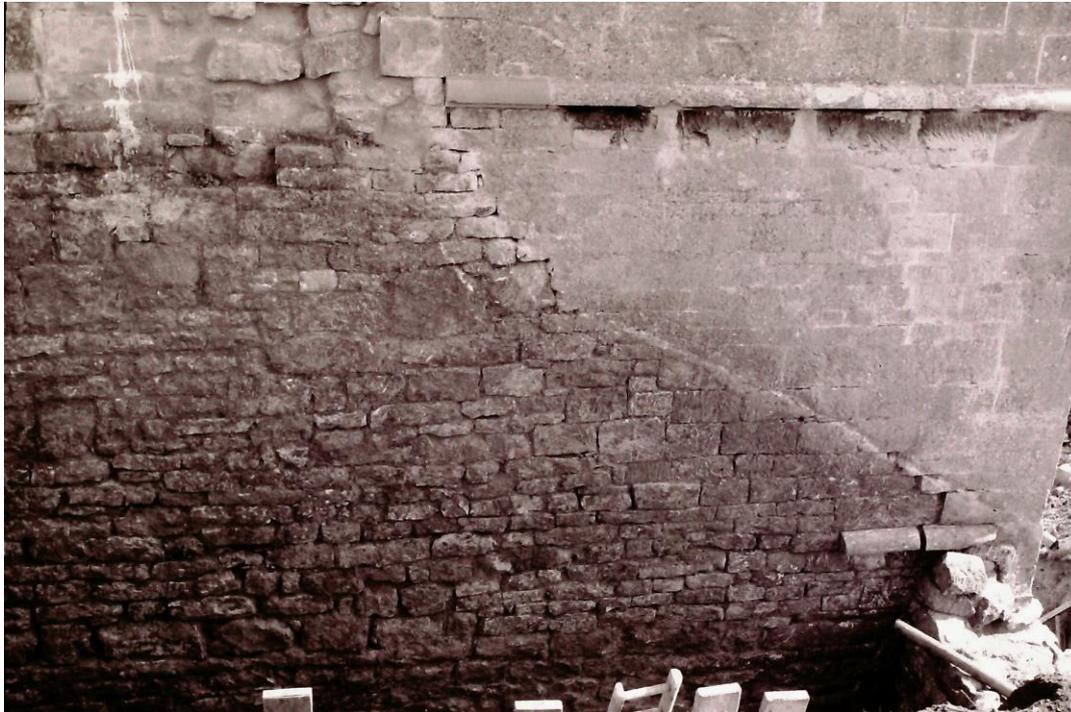
Figure 10: Exposed southwestern face of East Banqueting House after removal of terrace dump material. The slope of the terrace as it was in 1990 is visible as a tide mark

The quarter-round moulding is also at approximately the same height (c. 145.5m AOD) as the highest surviving section of the terrace wall (32) visible in the edge of the trench to the west and this may represent the original full height (c. 2.6m) of the vertical terrace wall. Above this level the southern face of the terrace embankment may have been either stepped or, more likely, sloped and which could have been grassed, planted with shrubs or paved. This may seem to be at odds with the 18th century copy of a contemporary drawing of the garden which suggest that the southern face of the *Terras Walk* had been revetted by a vertical wall face to its full height (see Everson 1989, Fig 2; Stanford 2007, 4), although other details of the garden depicted in this image, such as the layout of the Inner Garden and its flanking raised walkways, also appear to be less than entirely accurate (compare Everson 1989, Figs 2 and 3). Such a design might appear to be incongruous in a renaissance garden, but sloped terraces are a feature of the gardens of the Elizabethan Hatfield House, Hertfordshire (Bembridge 2010) and, as a wall over 5m high would have been needed to revet the full height of the terrace embankment, this may have been seen as a practical engineering solution to the construction of this section of the garden.

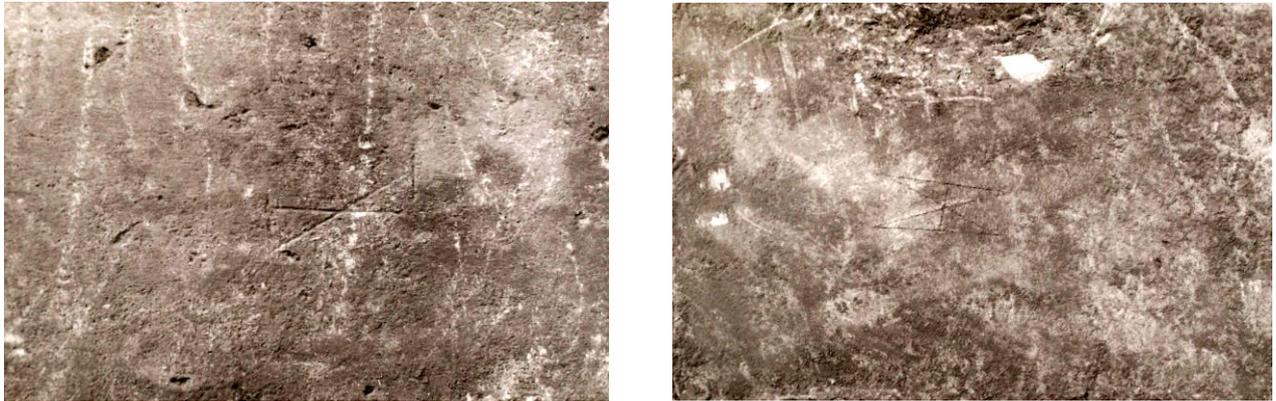
Figure 11: Mason marks visible on eastern face of butters (33)

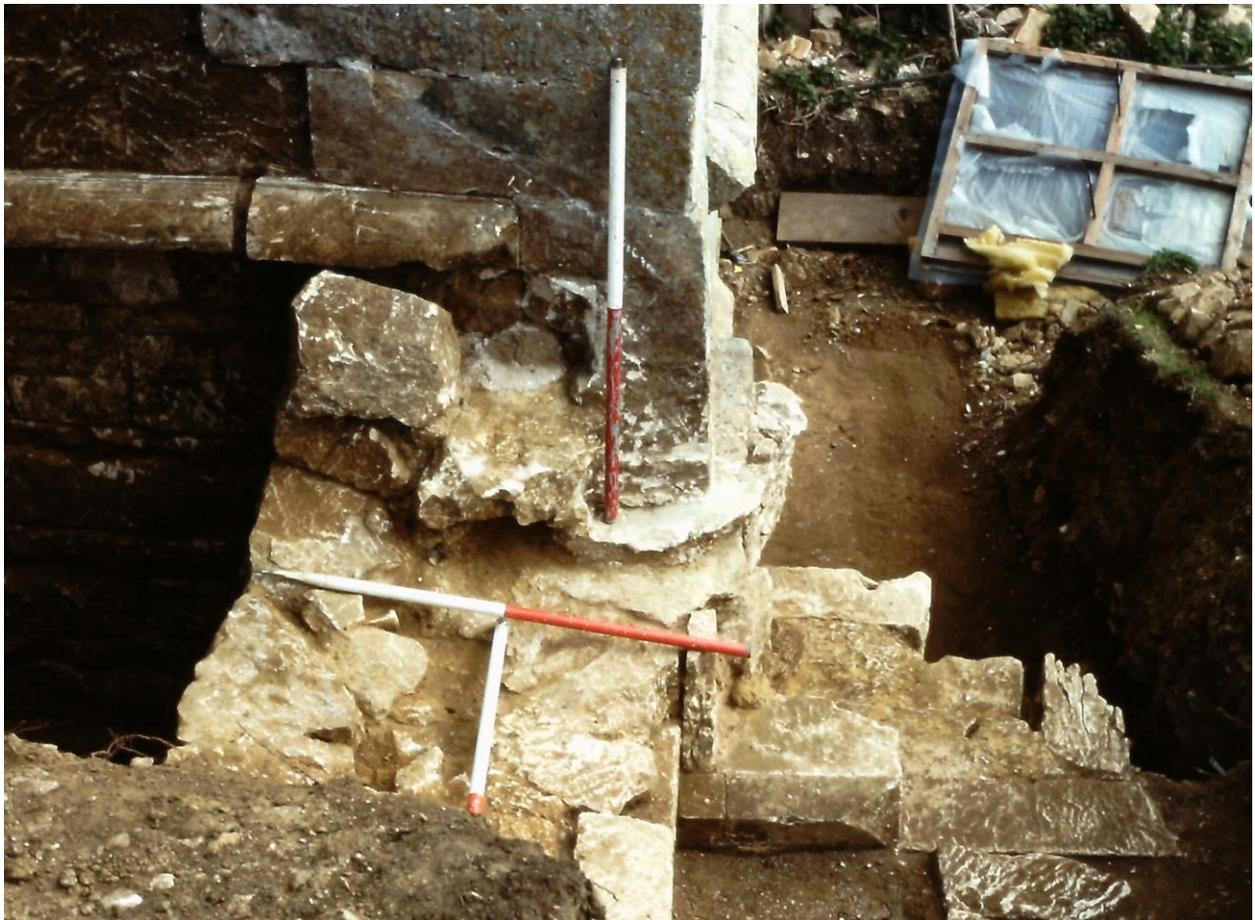
The only identified structural feature which appeared to date to the use of the Banqueting House was a further buttress (34) which had been constructed against the junction of the terrace wall (32) and the southern face of the Banqueting House (6). This buttress, which was c. 90cm wide and protruded out from the face of the wall by c. 1.10m, was built of large smoothly-faced ashlar blocks of limestone, which displayed two clear mason's marks, with a smaller rubble core in a matrix of fine yellowish brown clay sand and bonded with a pinkish sandy mortar. The finely smoothed ashlar construction overlay a cruder foundation of large limestone blocks measuring c. 18 x 18cm to 39 x 19 cm. The buttress may have abutted the southern wall of the Banqueting House (6) but was keyed into the face of terrace revetment (32). It did, however, appears to be a later addition and was built of differently finished stone and did not include the chamfered course evident on both terrace wall (32) and buttress (33). Although it only survived to a height of c. 1.34m, buttress (34) may originally have been higher as the string course at the level of the Banqueting House's first floor (and also that at upper floor level directly above) was missing at its southwestern corner. There was, however, no obvious scar against the face of the building at this point where the buttress had been attached to the earlier building. It is not known for certain when Buttress (34) was added, but it may have been built at the same time as the massive buttresses against the Banqueting House's eastern wall which were a later addition to the building to address some perceived or actual stability problems (Morriss 2000, 21).

Figure 12: Additional butters added to southern terrace wall. View east, scale 1m (50cm divisions)
